# Photographic Record Cascade Mine Drainage

DSL-AMRB 91-001

Near Towns of Centerville, Stockett and Belt  
Cascade County, Montana

December, 1992  
Robert Peccia & Associates

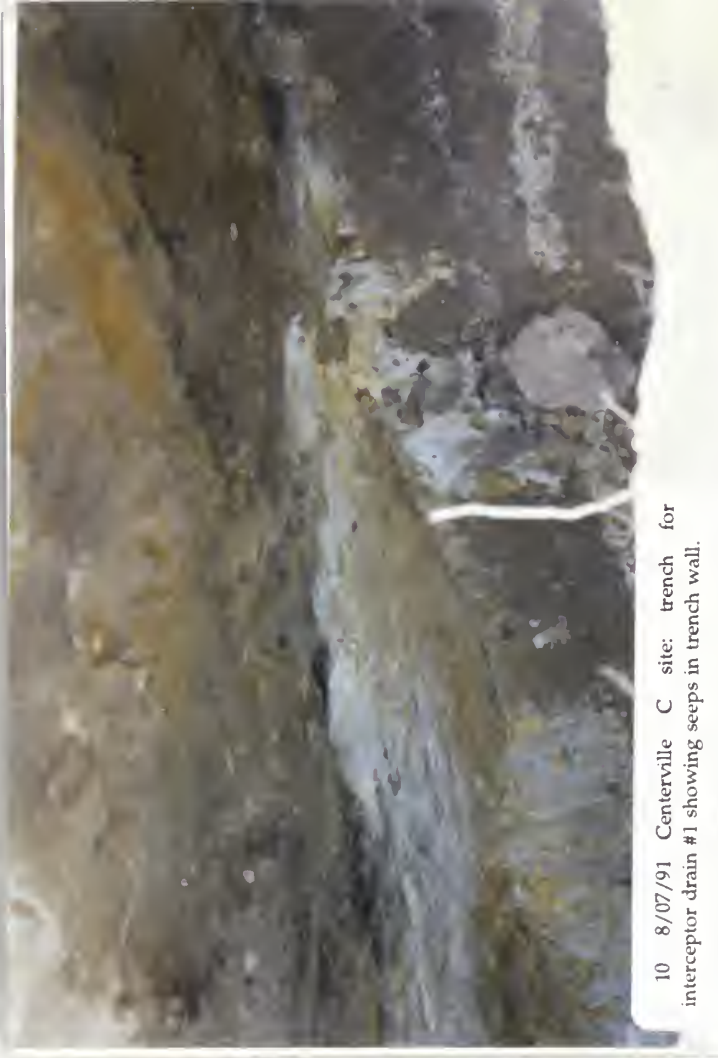
9 8/07/91 Centerville C site: trench for interceptor drain #1 showing seeps in trench wall.

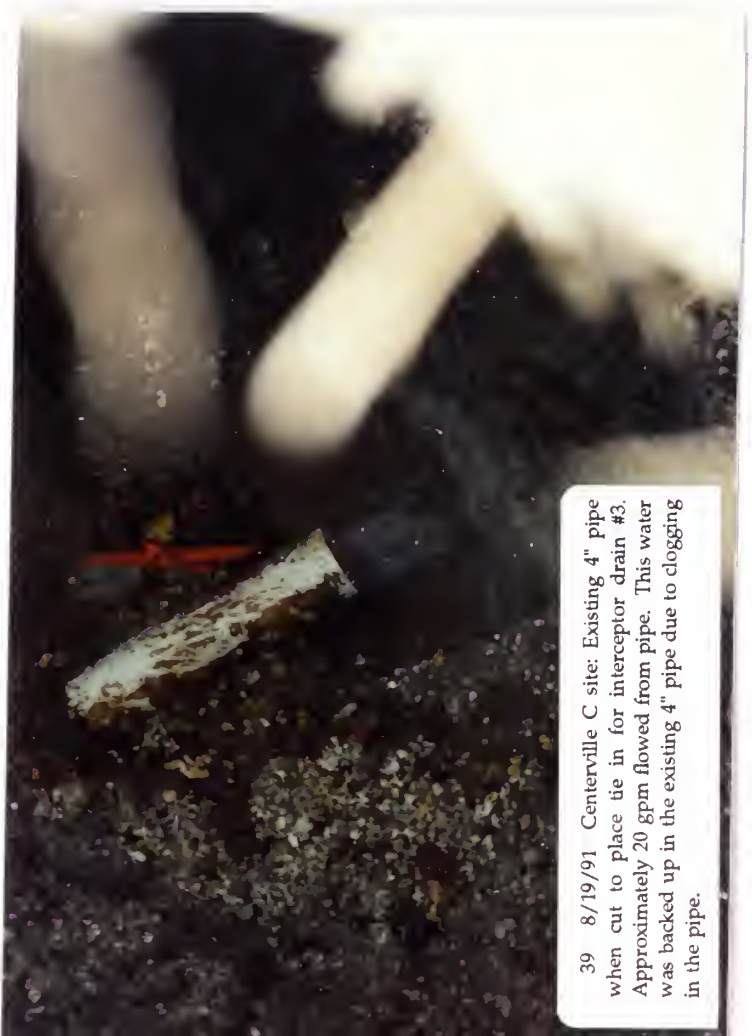
39 8/19/91 Centerville C site: Existing 4" pipe when cut to place tie in for interceptor drain #3. Approximately 20 gpm flowed from pipe. This water was backed up in the existing 4" pipe due to clogging in the pipe.

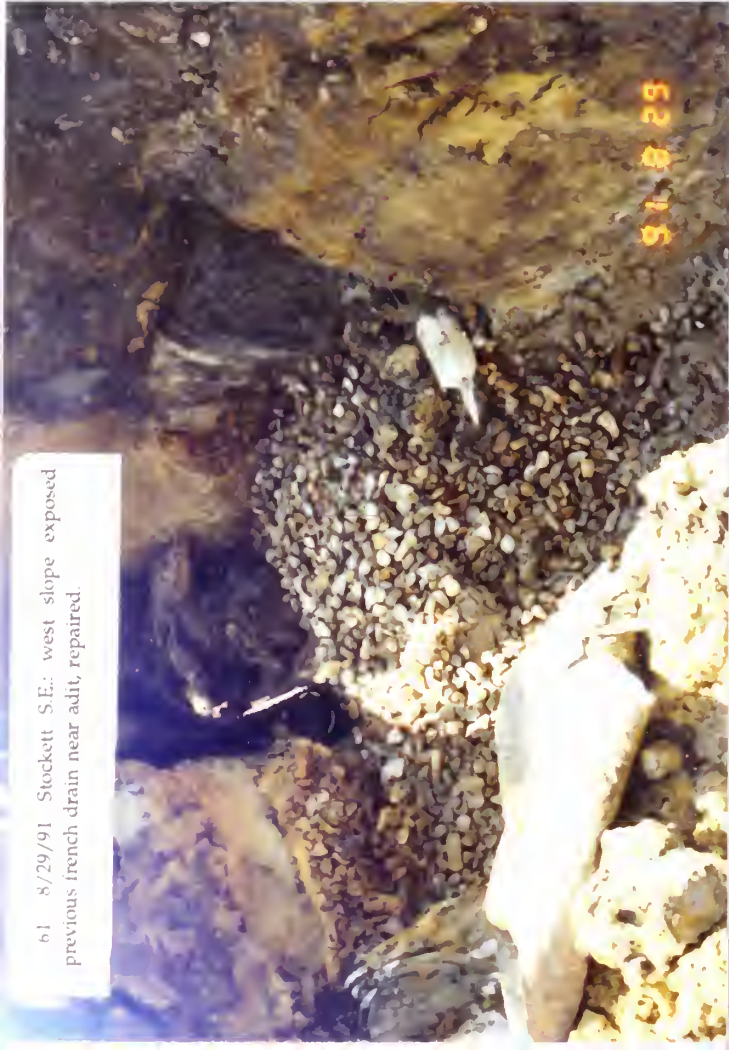
61 8/29/91 Stockett S.E.: west slope exposed  
previous trench drain near adit, repaired.

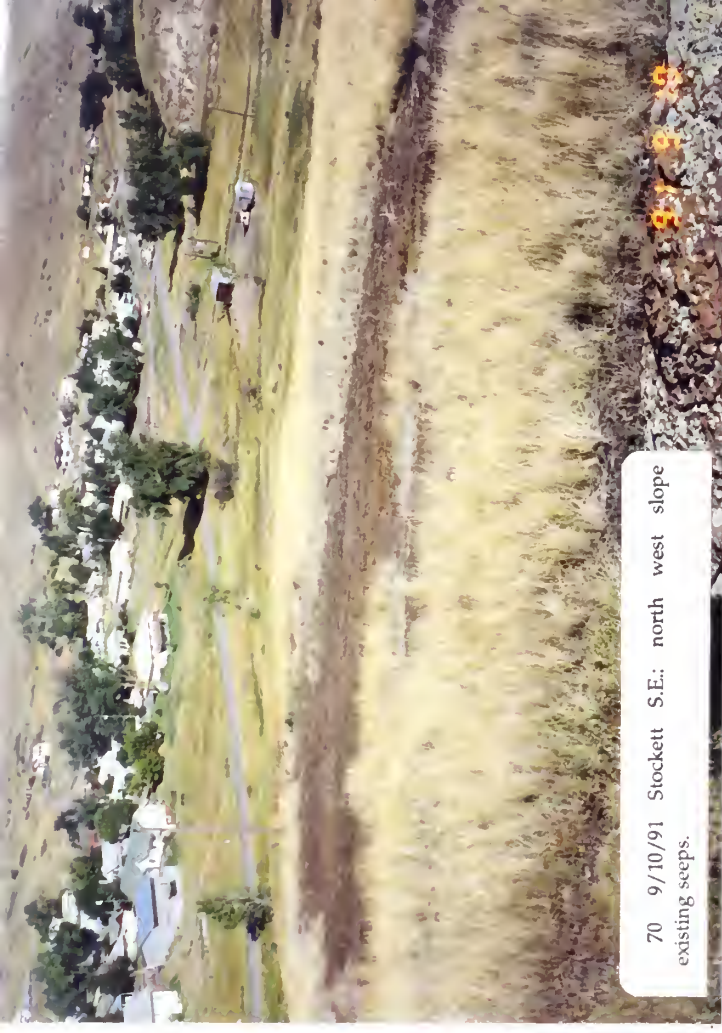
70 9/10/91 Stockett S.E.: north west slope  
existing seeps.

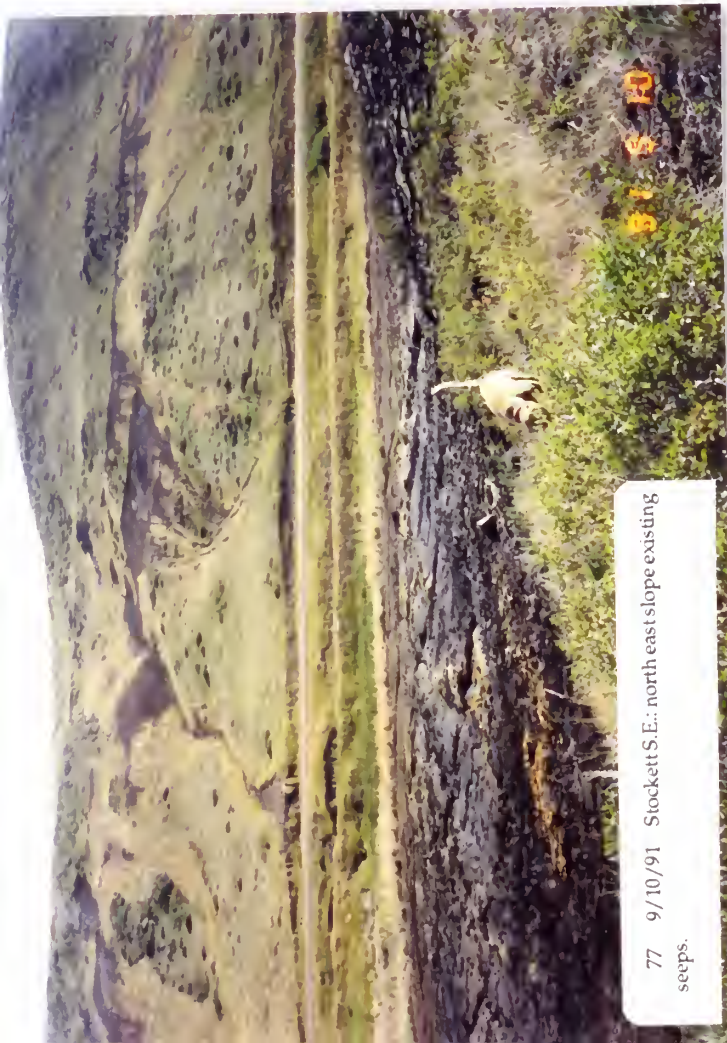
77 9/10/91 Stockett S.E.: north east slope existing  
seeps.

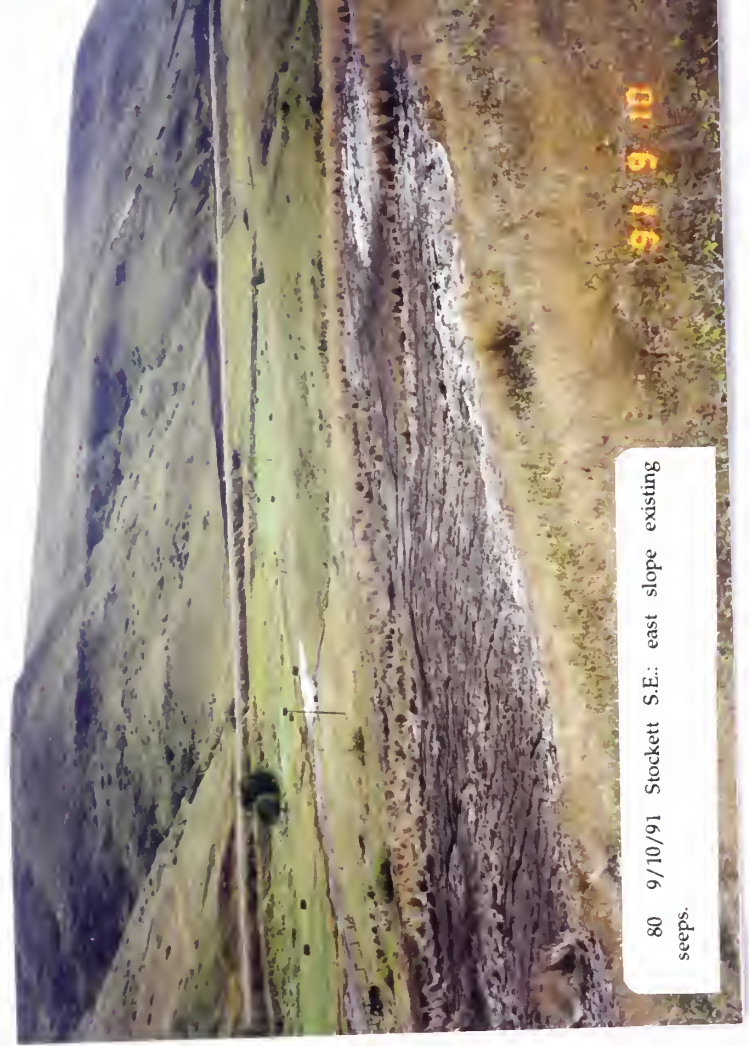
80 9/10/91 Stockett S.E.: east slope existing  
seeps.

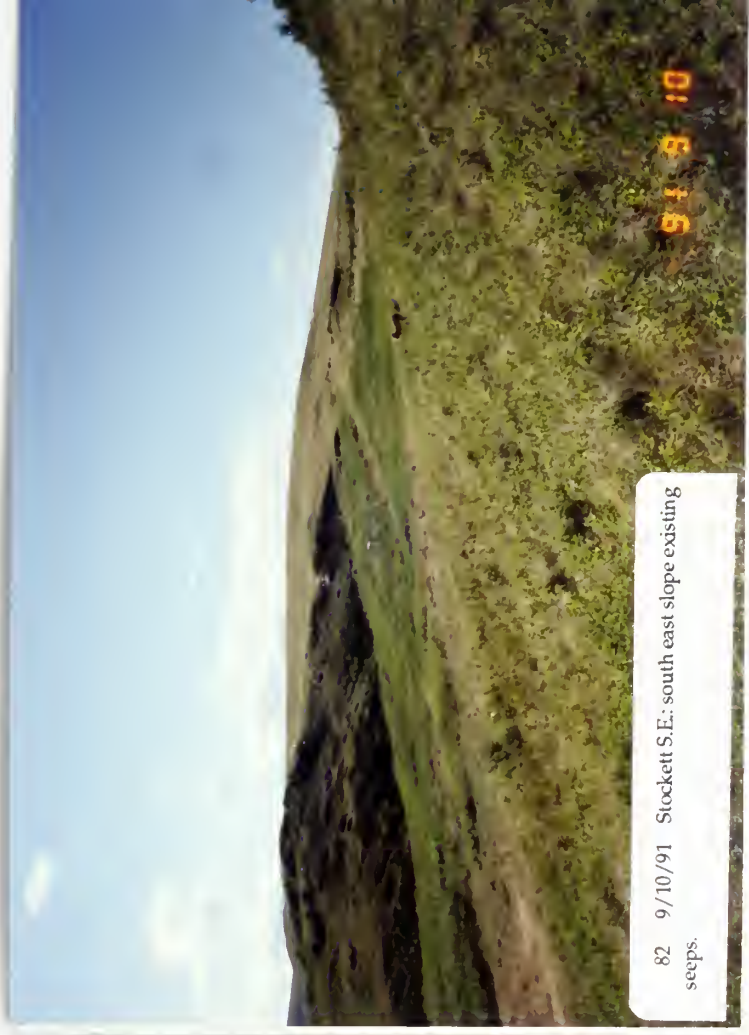
82 9/10/91 Stockett S.E.: south east slope existing  
seeps.

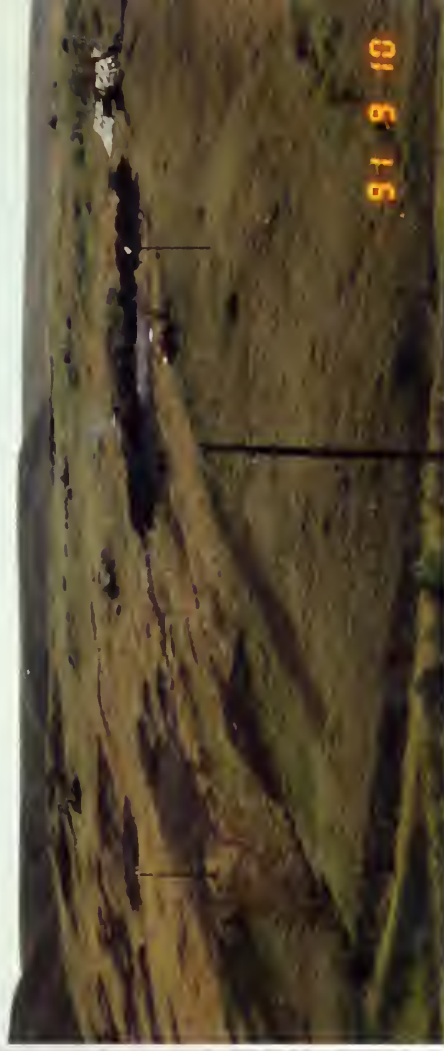
91 9/10/91 Stockett S.E.: overview of north slope existing seeps.

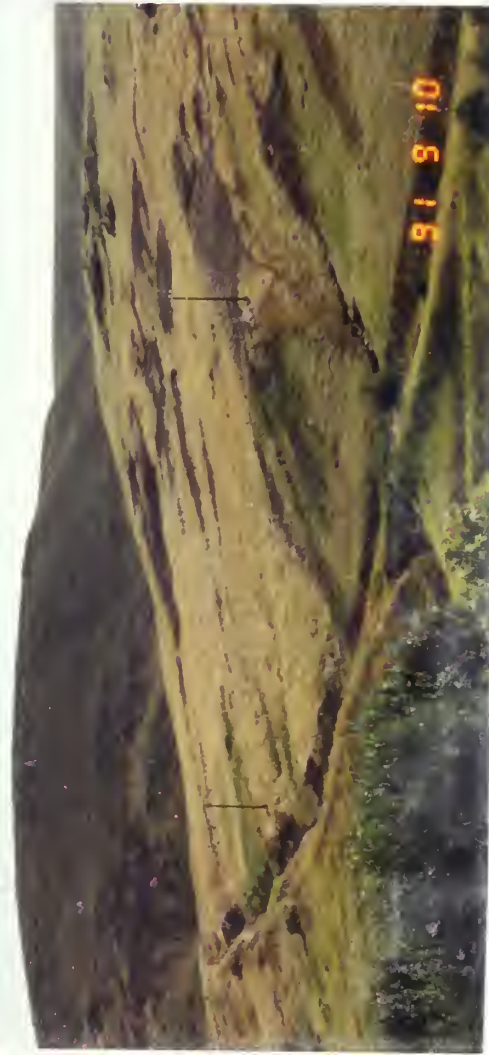
92 9/10/91 Stockett S.E.: overview of north west slope existing seeps.

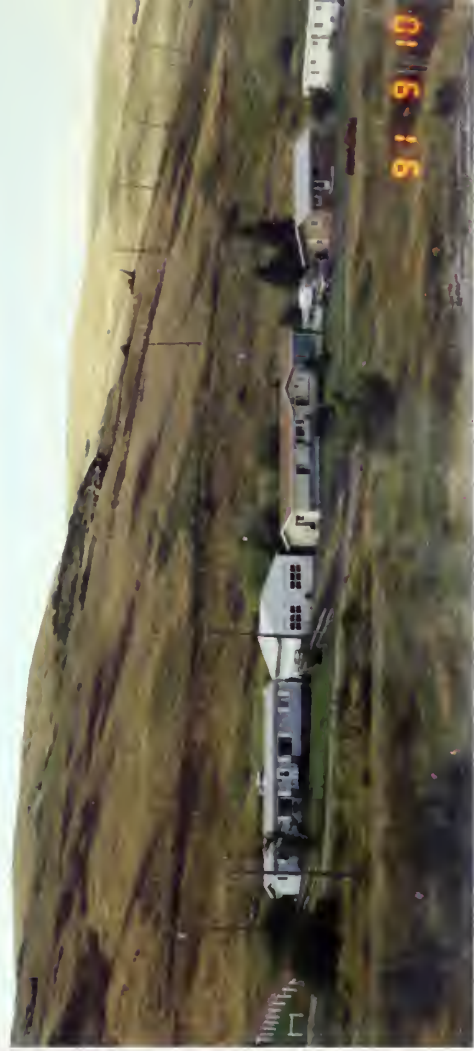
93 9/10/91 Stockett S.E.: overview of north west slope existing seeps.

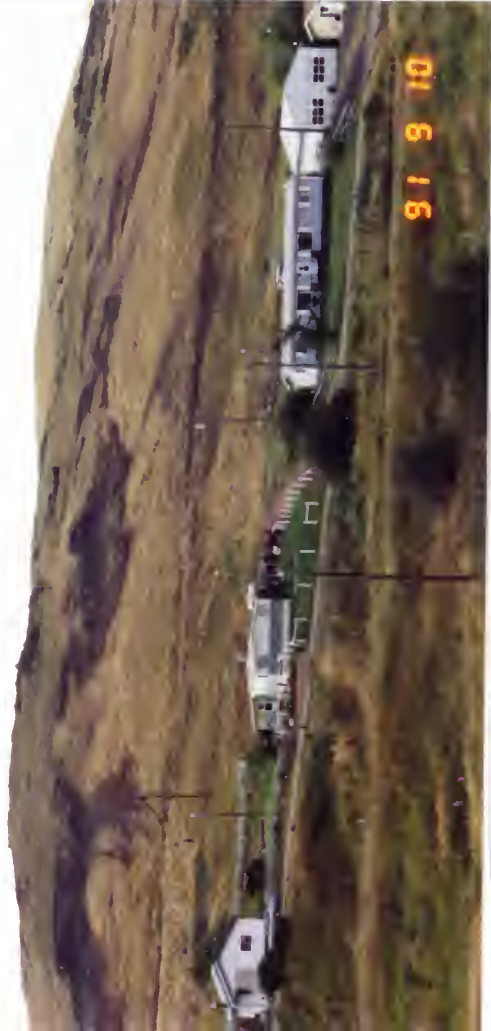
94 9/10/91 Stockett S.E.: overview of north east slope existing seeps.

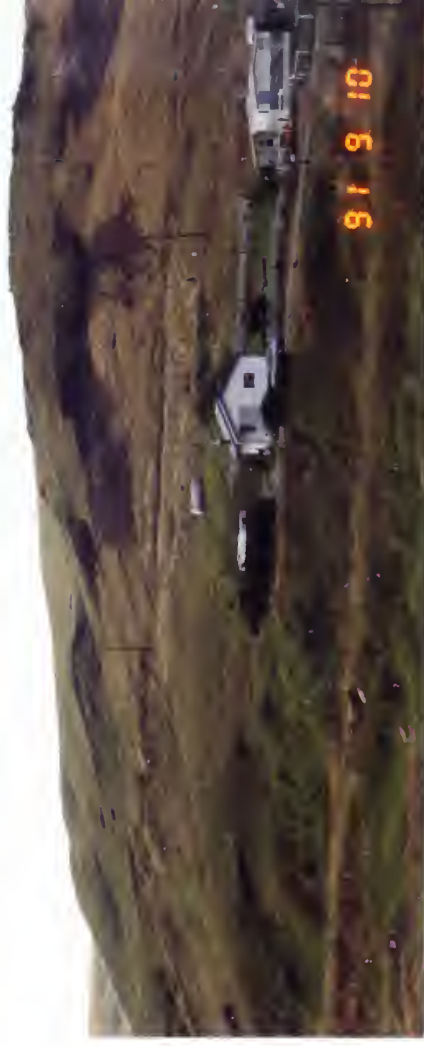
95 9/10/91 Stockett S.E.: overview of north east slope existing seeps.

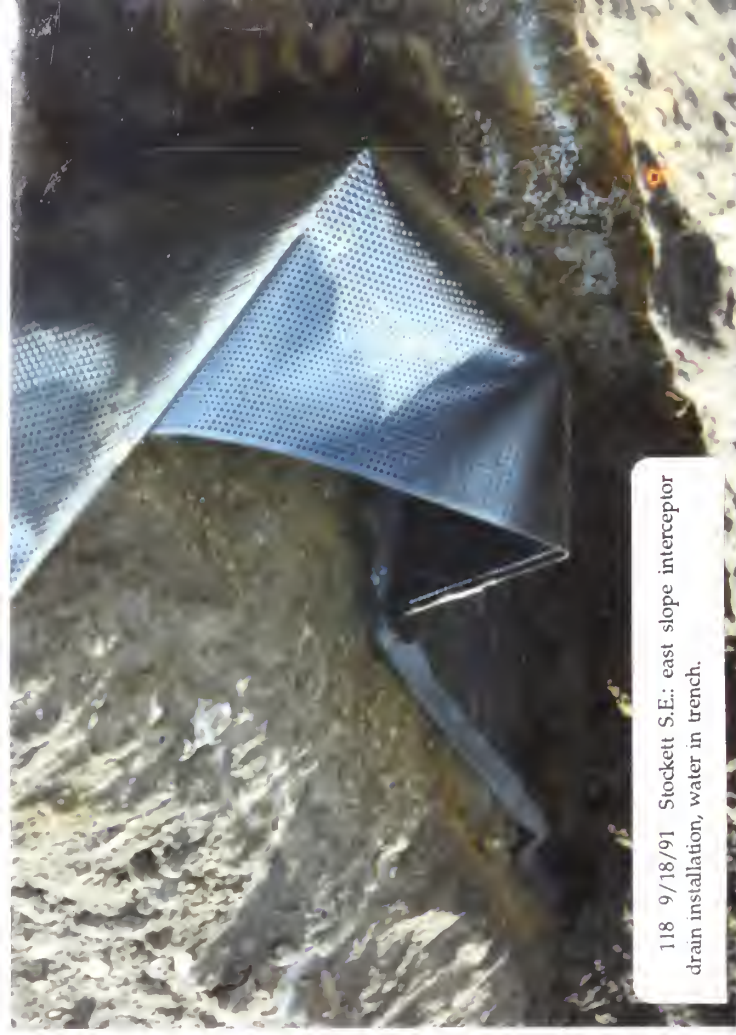
118 9/18/91 Stockett S.E.: east slope interceptor drain installation, water in trench.

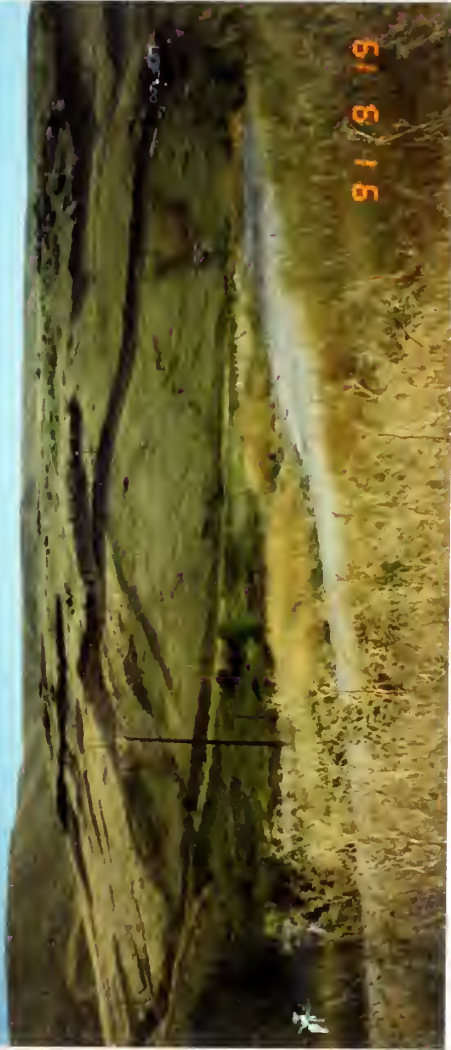
122 9/24/91 Stockett S.E.: south east coulee, view from below, landowner fencing in foreground.

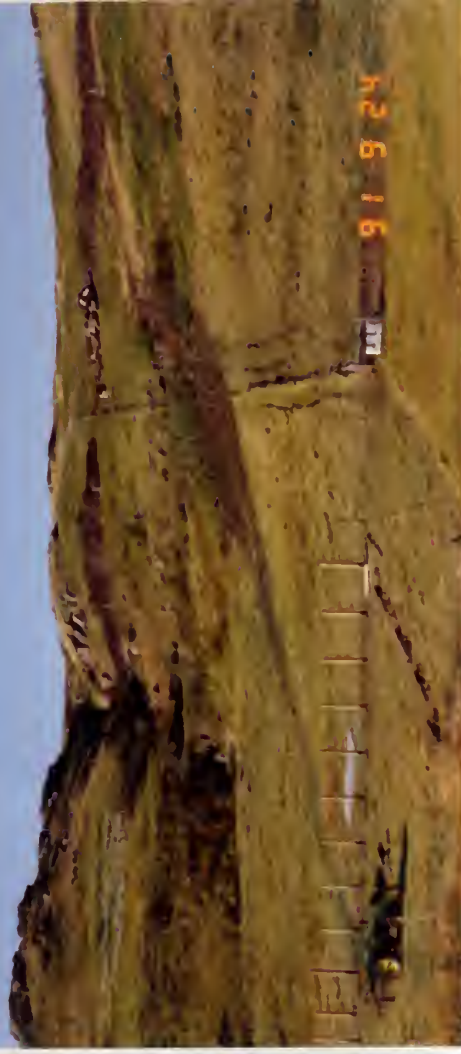
123 9/24/91 Stockett S.E.: east slope view from below.

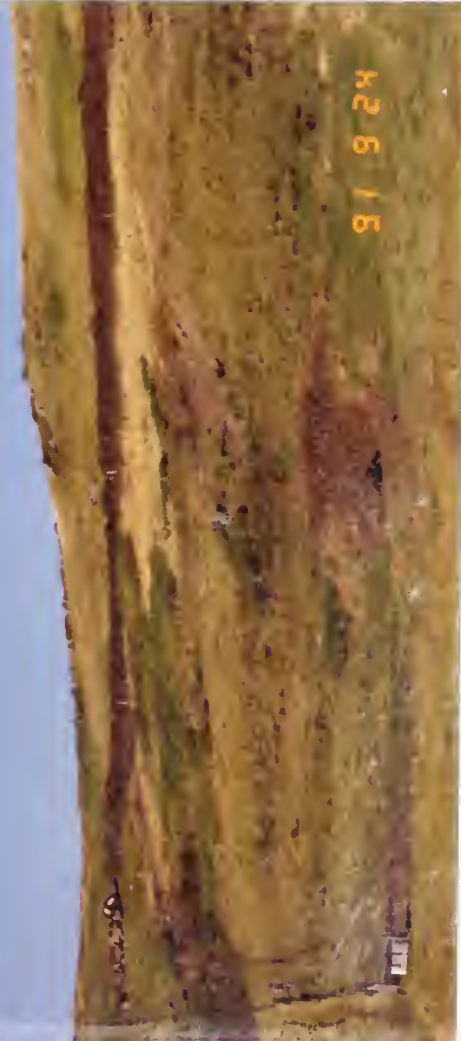
124 9/24/91 Stockett S.E.: east slope view from below.

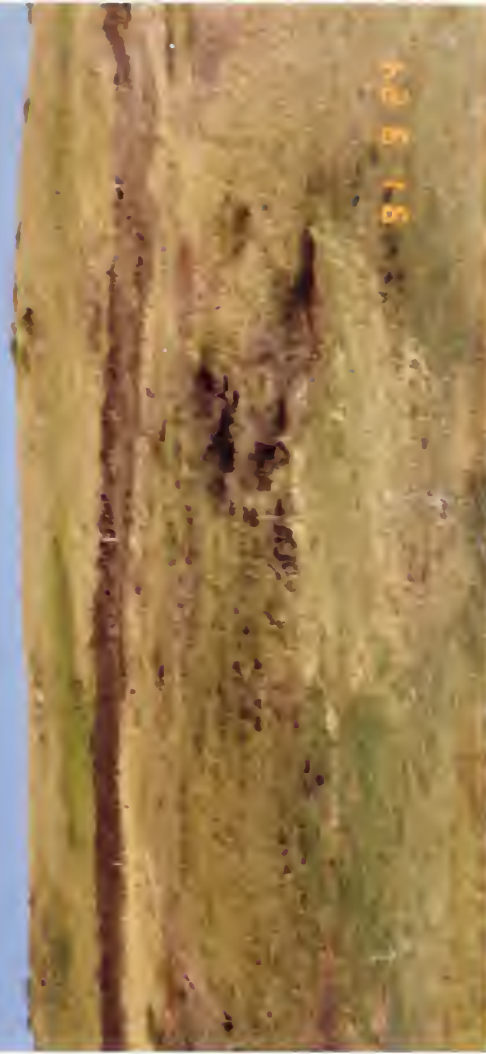
125 9/24/91 Stockett S.E.: north east slope view from below.

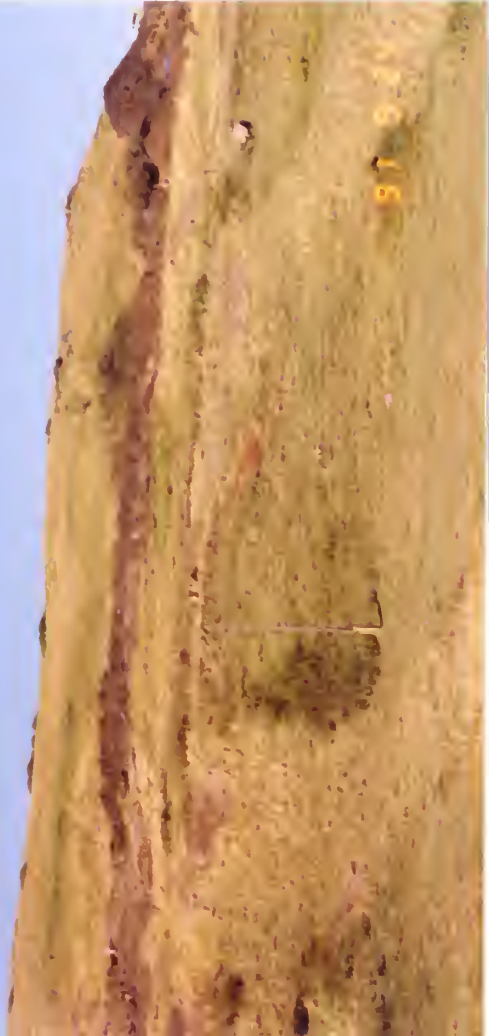
126 9/24/91 Stockett S.E.: north slope view from below.

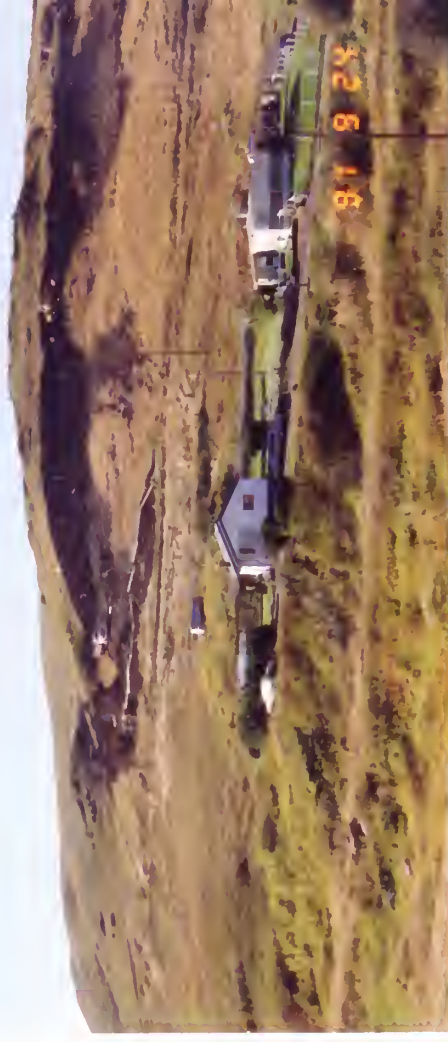
127 9/24/91 Stockett S.E.: west slope overview.

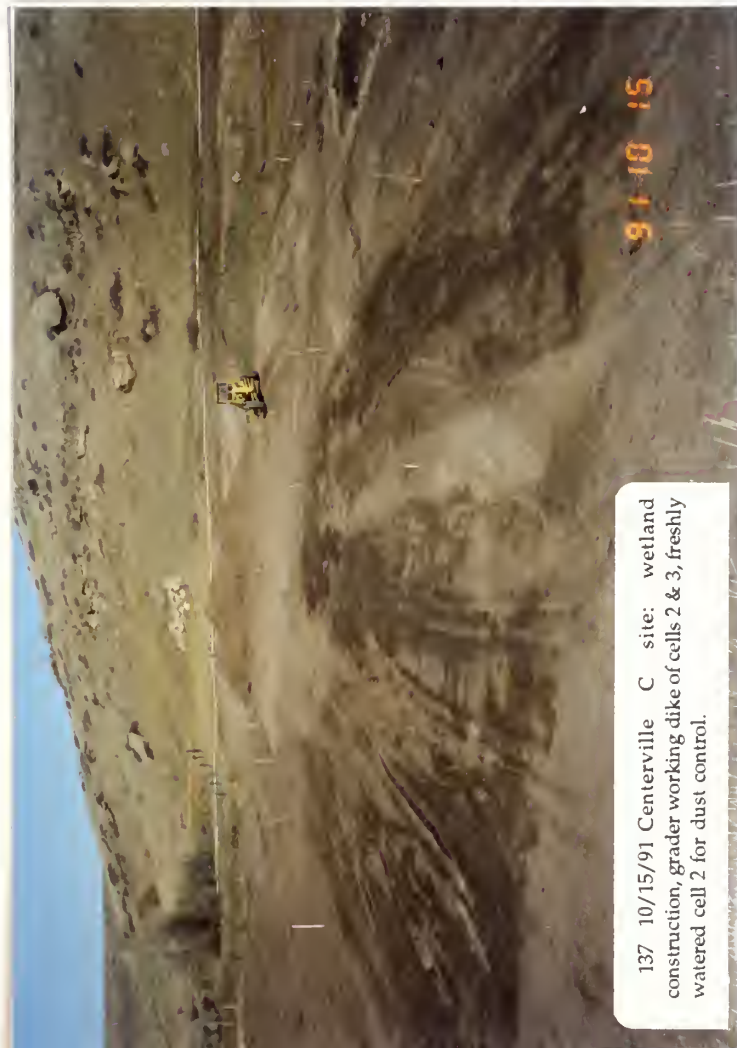
137 10/15/91 Centerville C site: wetland construction, grader working dike of cells 2 & 3, freshly watered cell 2 for dust control.

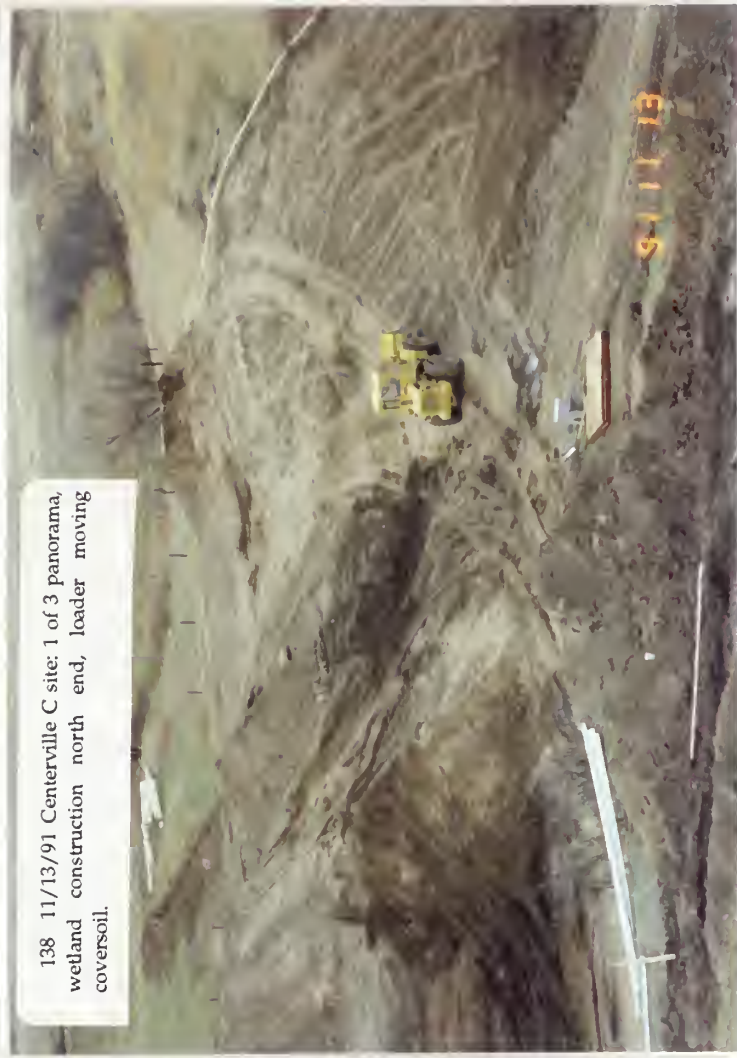
138 11/13/91 Centerville C site: 1 of 3 panorama, wetland construction north end, loader moving coversoil.

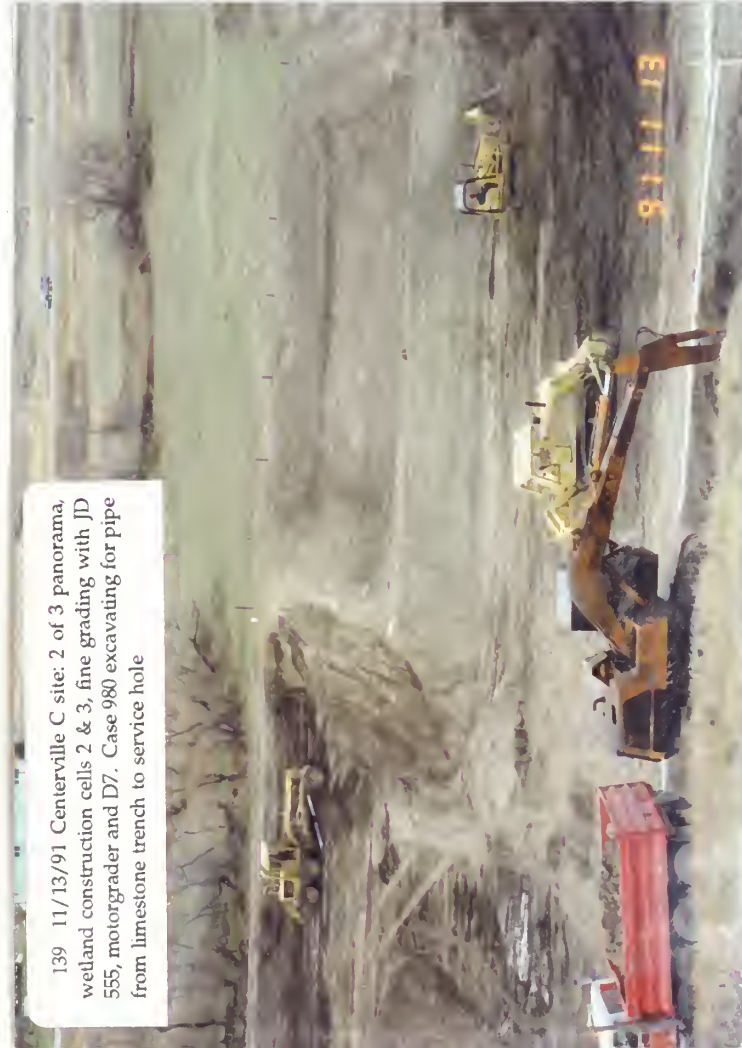
139 11/13/91 Centerville C site: 2 of 3 panorama, wetland construction cells 2 & 3, fine grading with JD 555, motorgrader and D7. Case 980 excavating for pipe from limestone trench to service hole

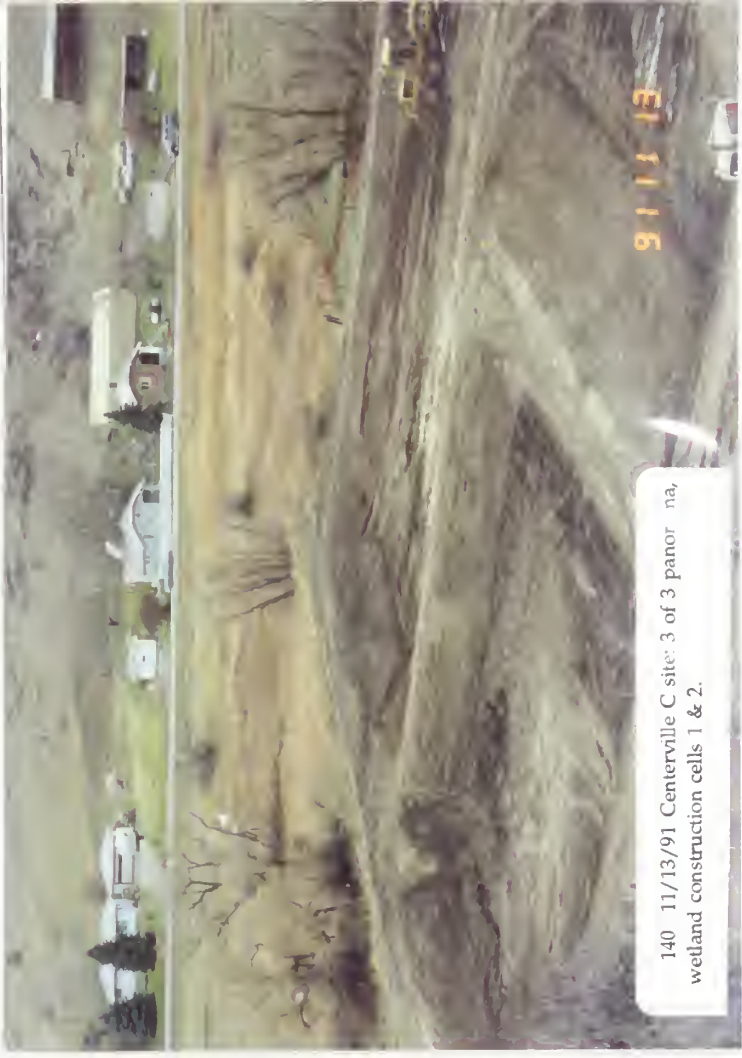
140 11/13/91 Centerville C site: 3 of 3 panorama, wetland construction cells 1 & 2.

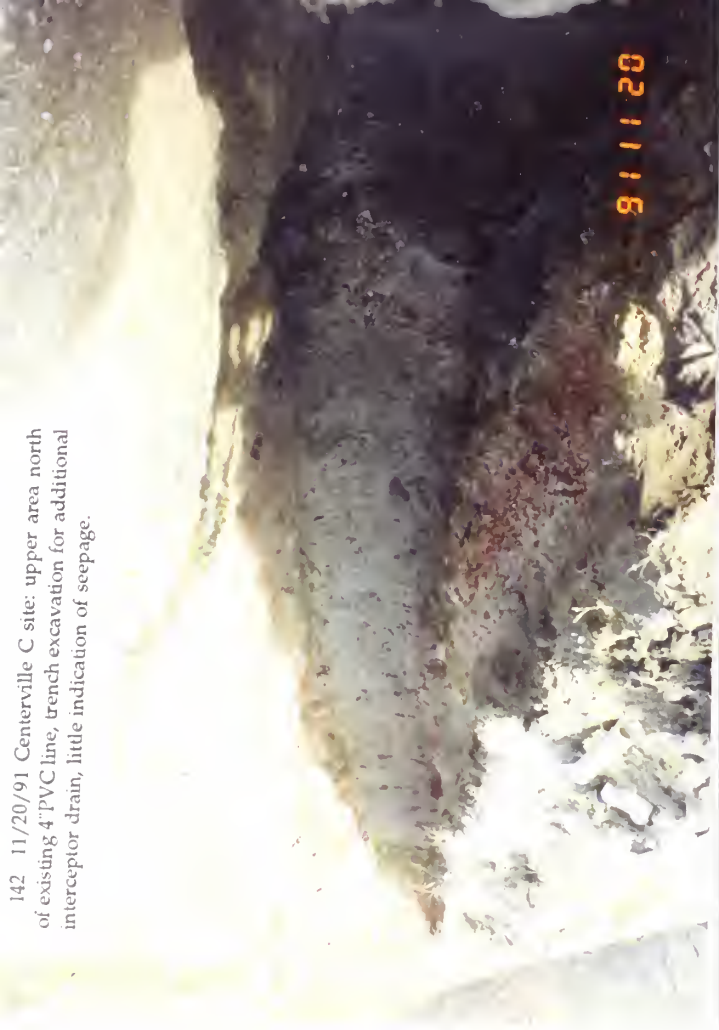
142 11/20/91 Centerville C site: upper area north of existing 4" PVC line, trench excavation for additional interceptor drain, little indication of seepage.

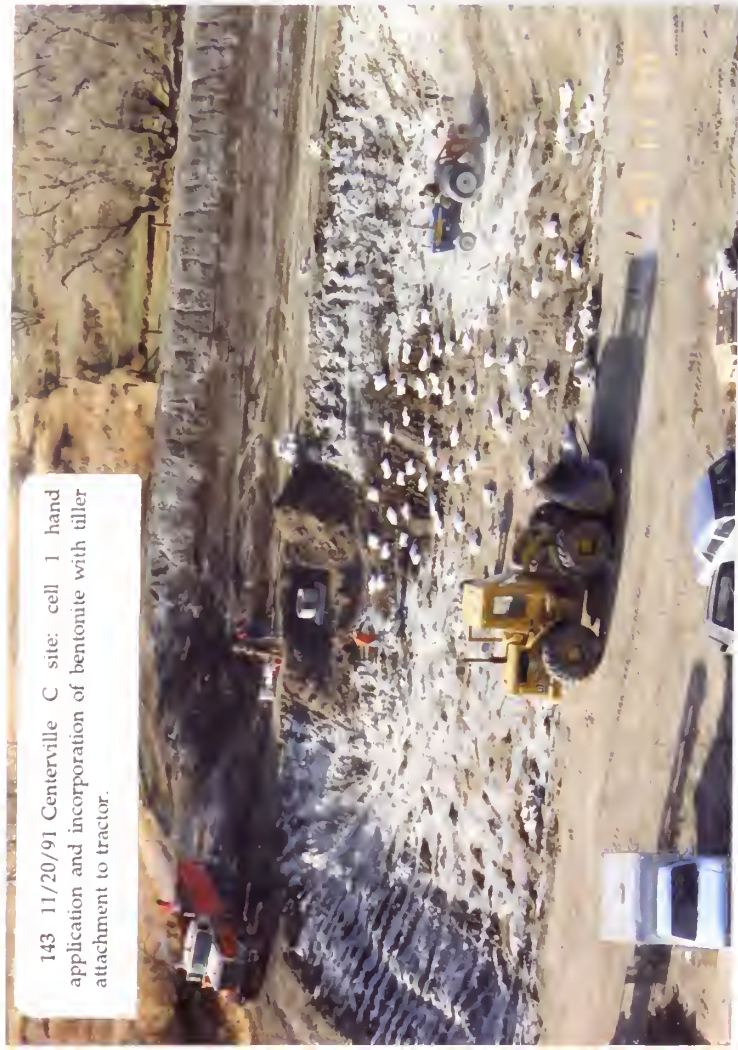
143 11/20/91 Centerville C site: cell 1 hand application and incorporation of bentonite with tiller attachment to tractor.

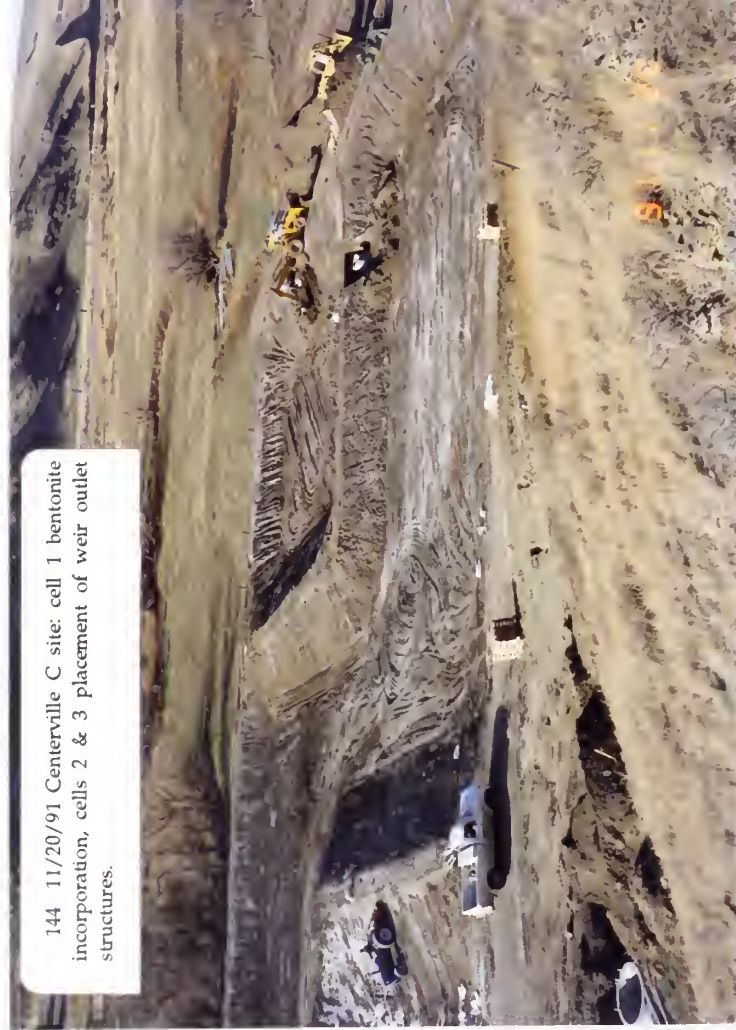
144 11/20/91 Centerville C site: cell 1 bentonite incorporation, cells 2 & 3 placement of weir outlet structures.

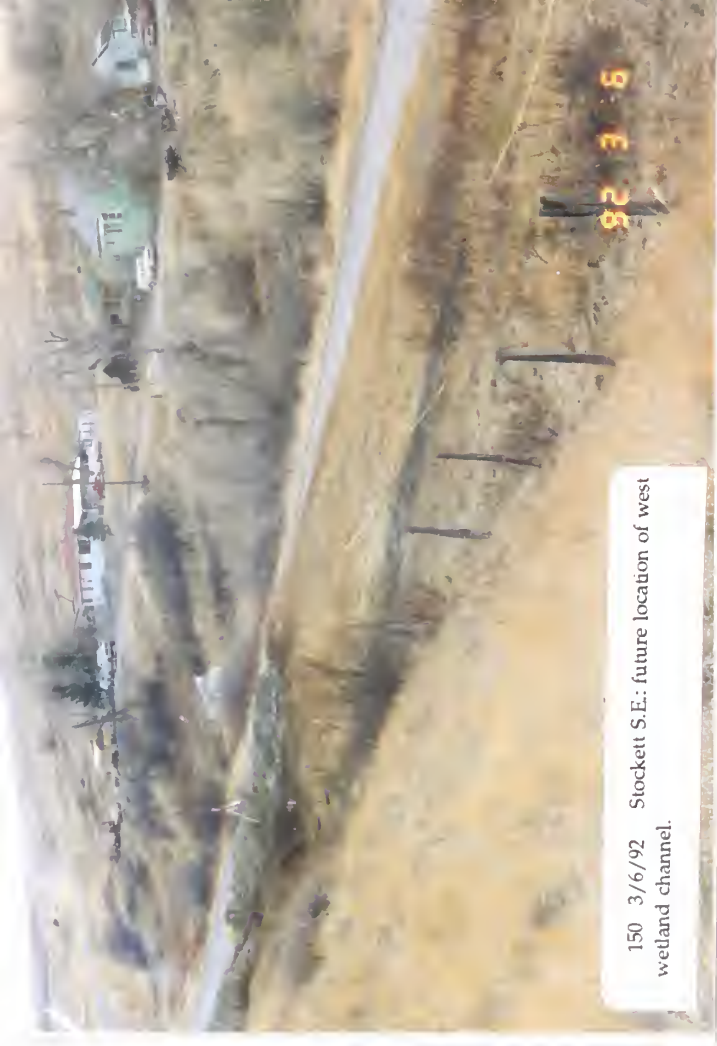
150 3/6/92 Stockett S.E.: future location of west wetland channel.

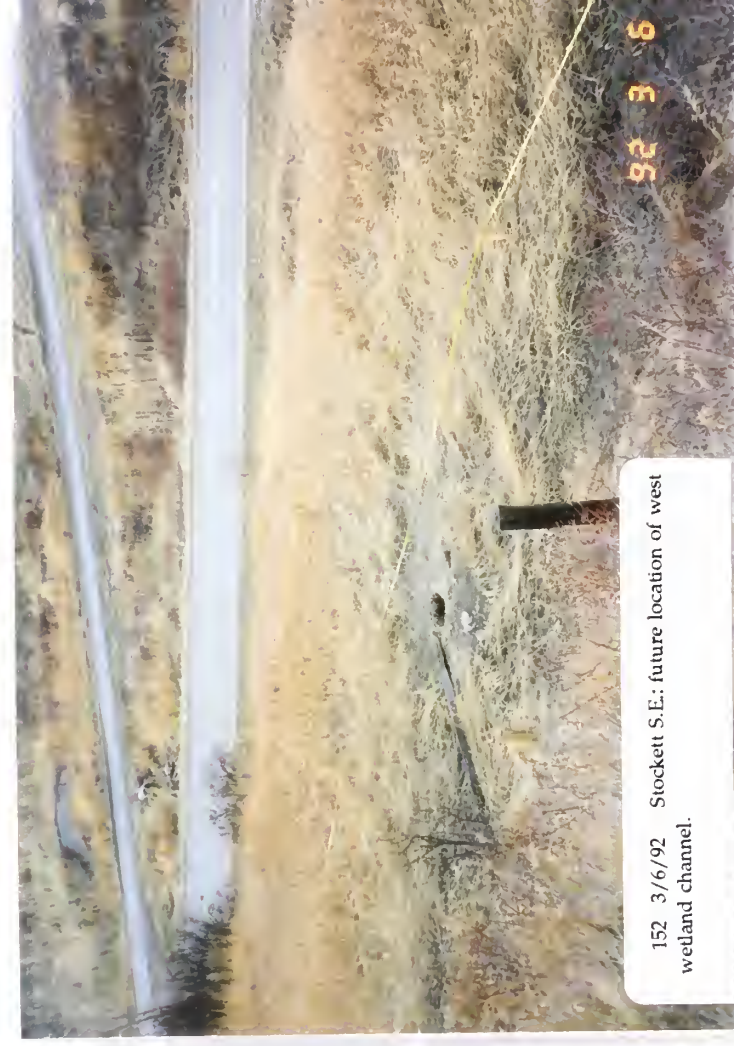
152 3/6/92 Stockett S.E.: future location of west wetland channel.

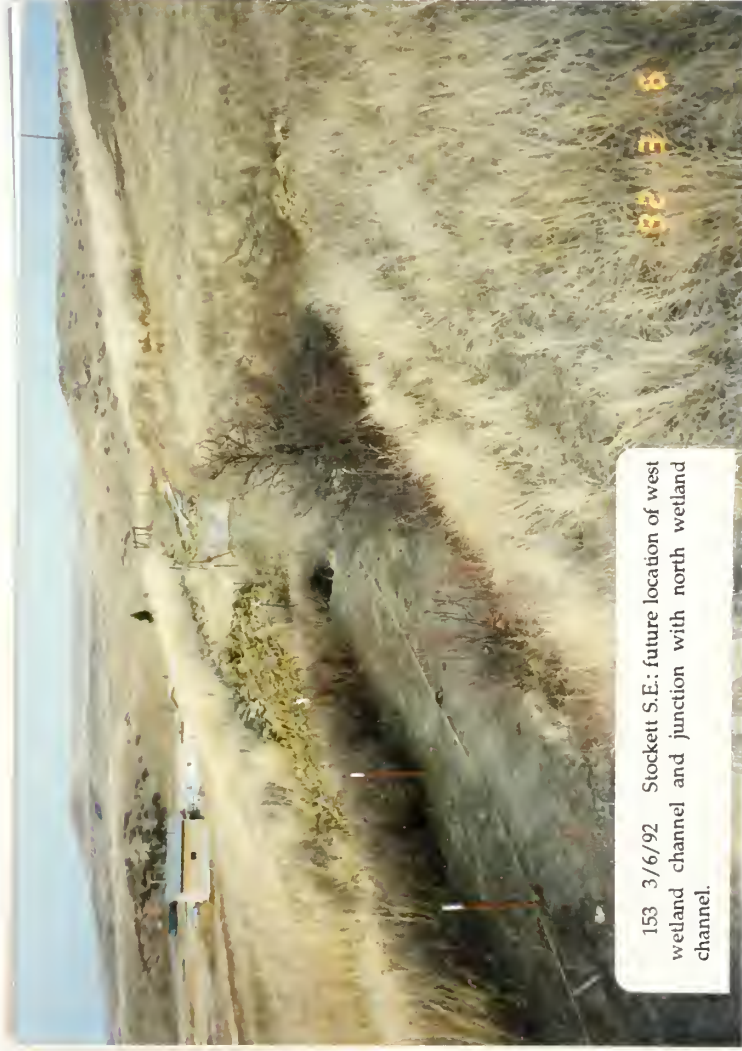
153 3/6/92 Stockett S.E.: future location of west wetland channel and junction with north wetland channel.

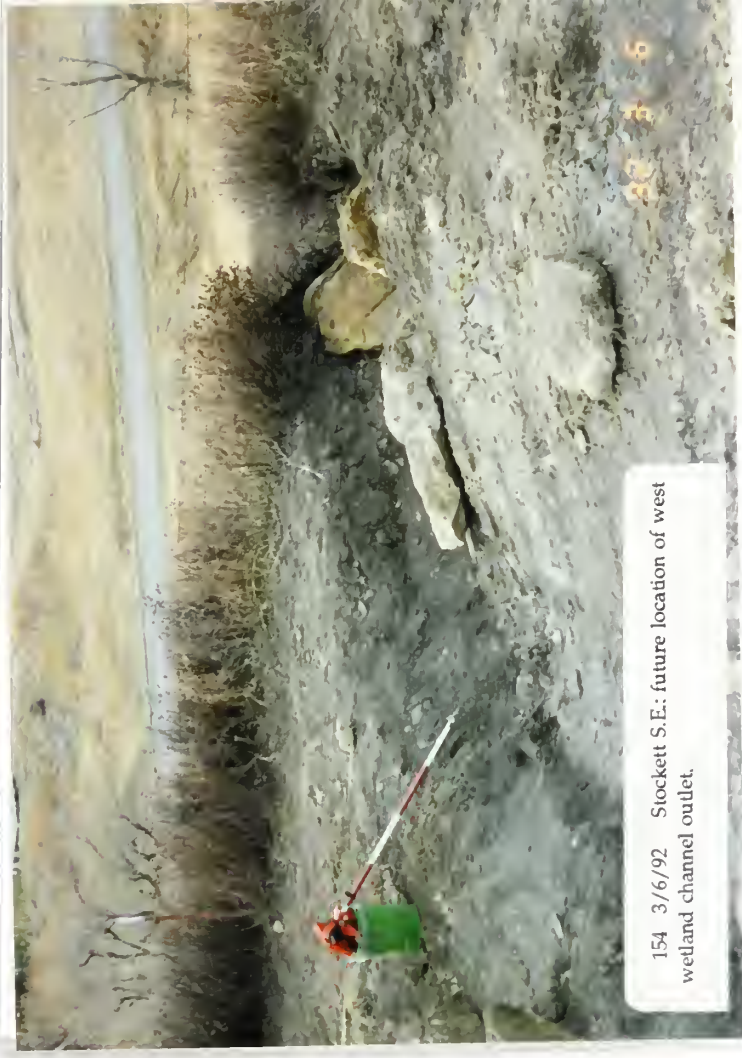
154 3/6/92 Stockett S.E.: future location of west wetland channel outlet.

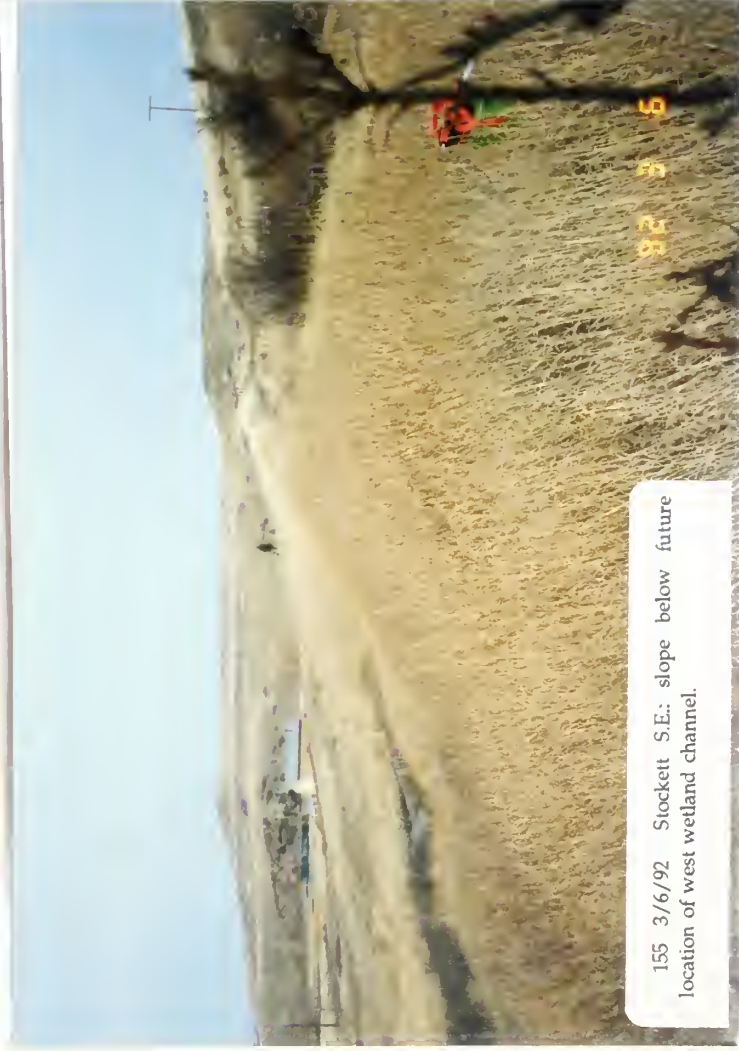
155 3/6/92 Stockett S.E.: slope below future location of west wetland channel.

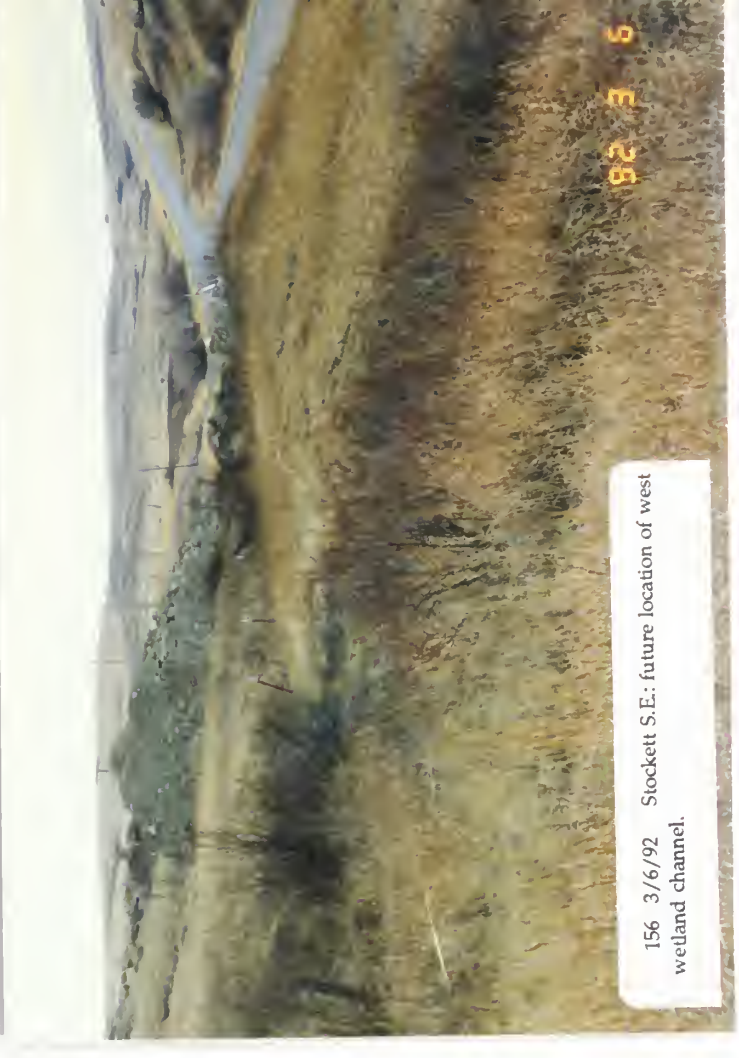
156 3/6/92 Stockett S.E.: future location of west wetland channel.

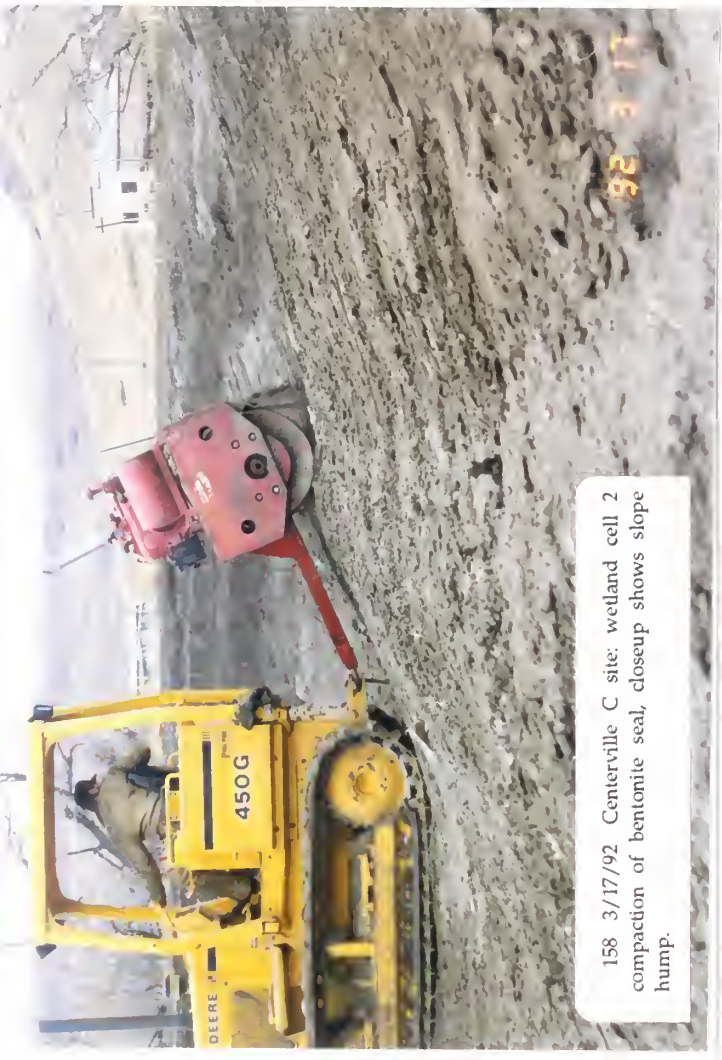
158 3/17/92 Centerville C site: wetland cell 2  
compaction of bentonite seal, closeup shows slope  
hump.
